Reason

Solution

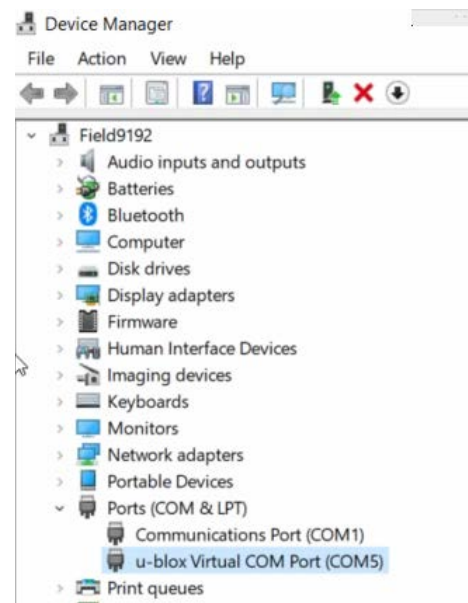
Verify the version of the GNSS drivers that is installed. Go to the Device Manager and find the u-blox Virtual COM Port, then go to Properties.

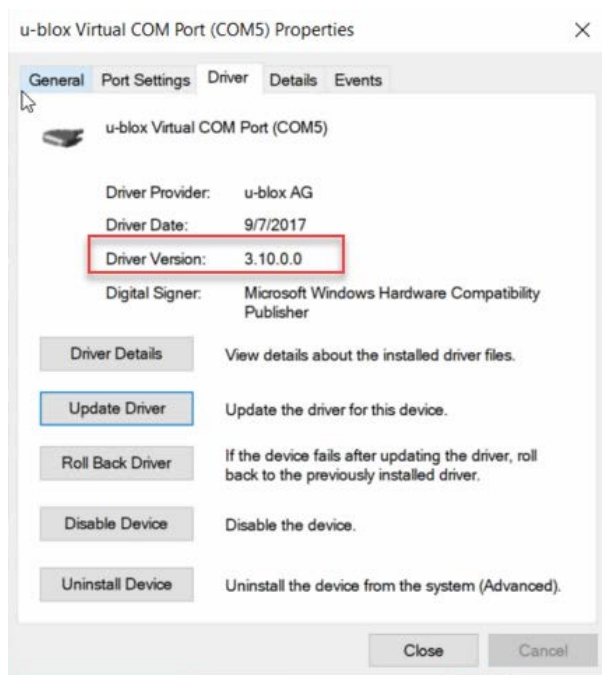
Go to the Driver tab and look at the Driver Version.

If the version is 2.30, no further action is required. If the version is 3.10, the driver will need to be rolled back to 2.30.

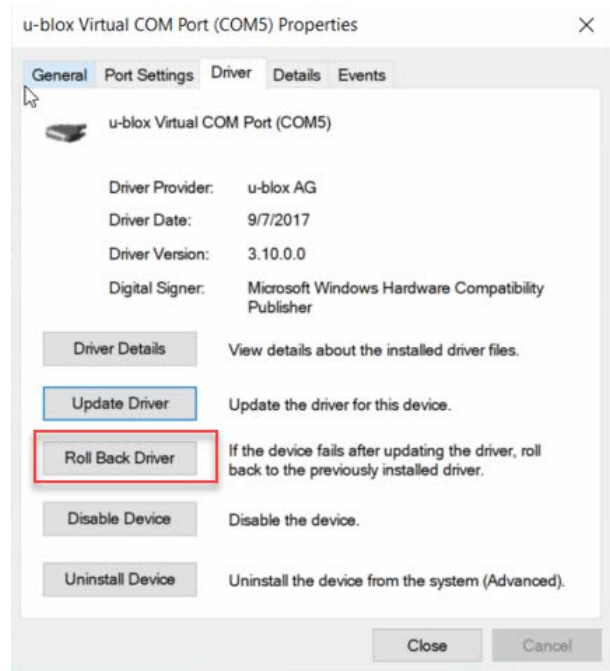
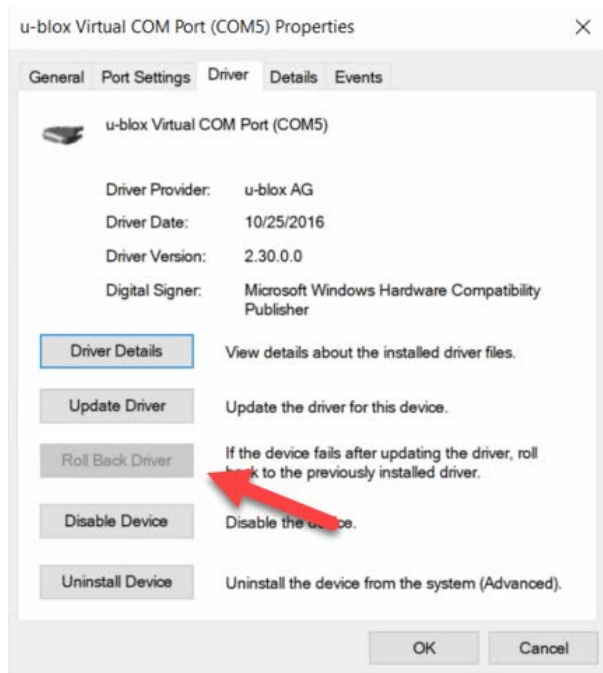
If the Roll Back Driver button is disabled, you'll have to download and install the 2.30 drivers.

If the Roll Back Driver button is enabled, tap on it. Select a reason for the roll back on the next screen then press OK. When the operation completes, the act of rolling back will prevent the drivers from being updated automatically in the future.

The v2.30 drivers can be downloaded from these links:

Download and install both drivers.
